## **Arpac Tray Packer Troubleshooting Report**

Troubleshooting occurred on Sept 19, 2014

Written by Ben Neher – Westrock Automation Integration Engineer – 9/22/24

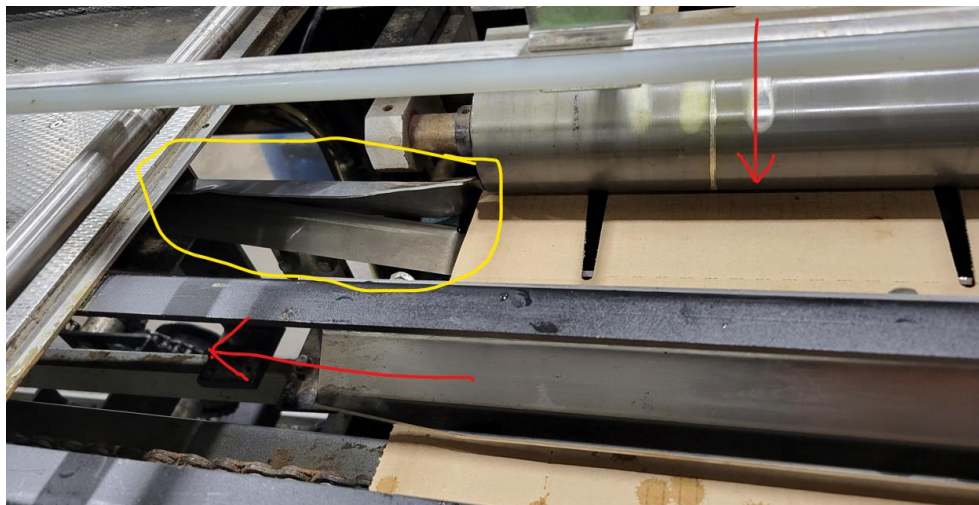
- Maintenance disconnected the safety door connectors and put them into the door switch to allow us to run the machine with the safety doors open to see what we were doing.
- They then removed the diamond plate to in order to see the path of the blank as it moves through the machine.
- They then set the blank detect PE window to 0,0 in order to remove the blank detect fault and trigger a blank by flagging a PE.
- Maintenance could then watch the blank go through and see any obstructions.

When we watched the blank go through the feed rollers, hit the end stop, and try to go downstream, we found that case was coming into the machine too hard and not straight, bouncing off the end stop, and then jamming on the fabricated piece which was bent since the last time the machine was taken apart (most likely from a box jam).

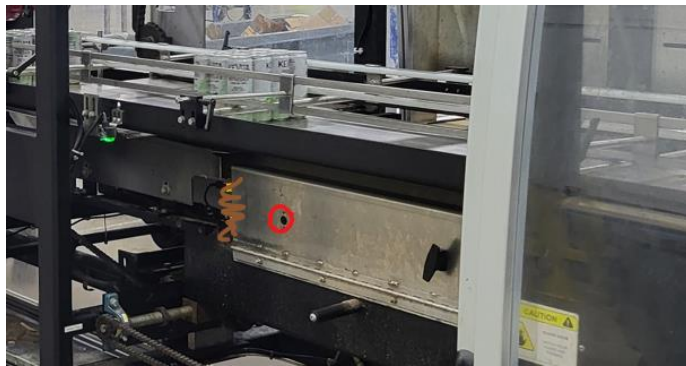
The end stop was missing one of its two handles. Per conversation with maintenance, it is sometimes beneficial when troubleshooting the blank system to loosen up the end stop so that blanks don't bounce off of it too hard. In the past, maintenance has jammed some cardboard in the door for some stability and alignment without making the stop too solid. This reduces bounce-back of the blank.

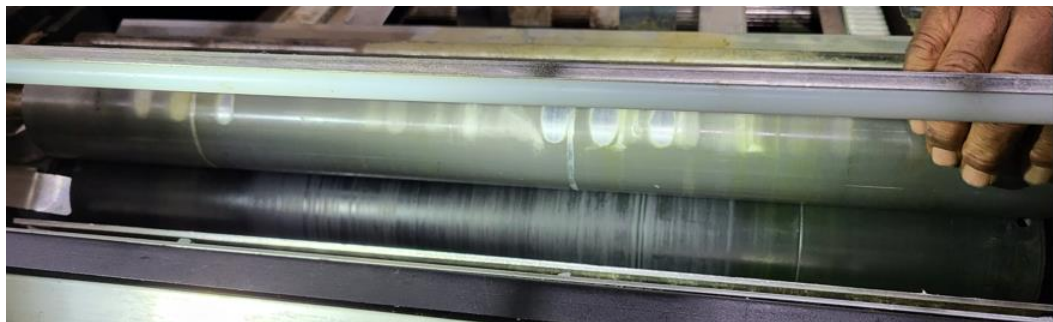
The rollers have a lot of wear on them which probably isn't helping the situation.

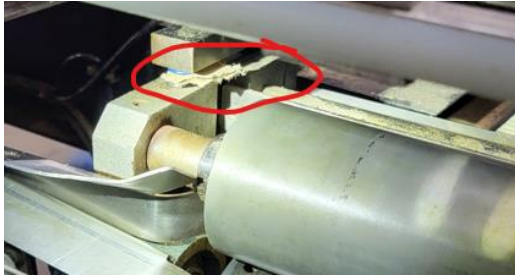
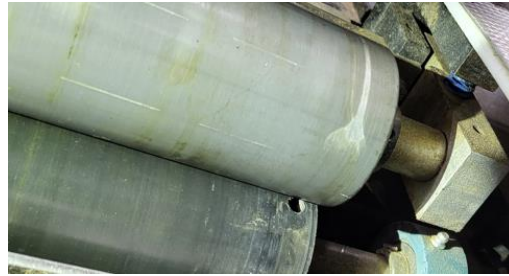
The bottom roller is fixed, and the top is tensioned using a spring on each end. If the tension is different, the blank can twist slightly in the roller. One of the springs is worn and has cardboard jammed into it to try to reduce the problem. We'll need a new spring.

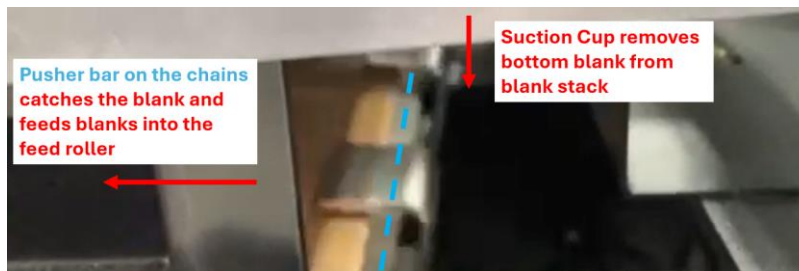
*Note that before Calub came to site, Joe re-aligned the feeder bar prior to the roller. The bar had slipped a chain link on one side (which is known to happen occasionally on these machines). This slightly modified the alignment of the case before it went into the feed roller*

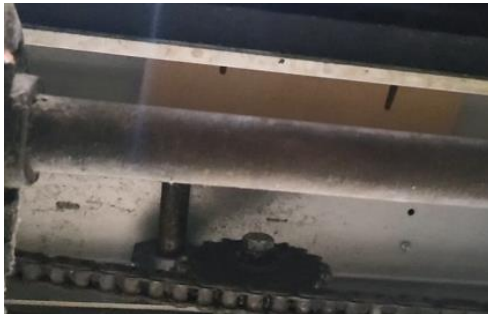
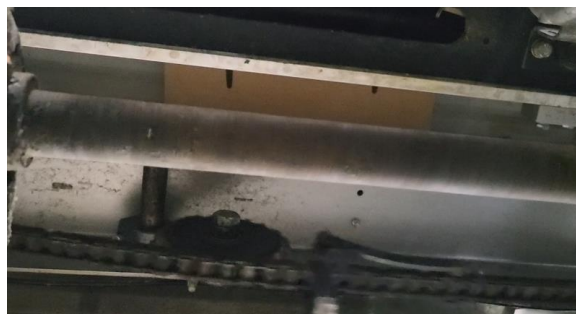
Below are pictures taken from the bottom of the machine that show the cases before the chain lug tries to push them downstream (not easy/safe pictures to take). The cases are not straight.

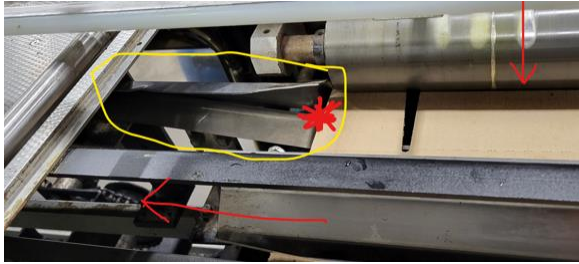
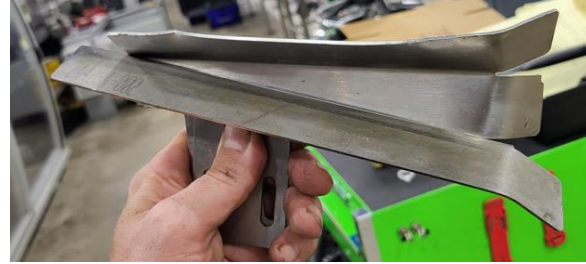
A fabricated guide piece (that clearly did not come with the machine) attempts to guide the blank from the perpendicular transfer to the downstream, but it was bent (it bends easily), and the case was jamming on the upper edge of the lower guide. The fabricated guide is two pieces that are angled and fastened together (and to the machine itself) with a bolt. The mounting and angling of the guide pieces must be correct for the blank transfer to occur smoothly as the case moves downstream on the box blank lug chain. Maintenance took the fabricated guide out and bent the lower guide with some pliers to get the correct orientation. They then put the guide back in the machine in a way that looked to be correct (who knows how long it will stay correct).

*Per discussion with maintenance, they had a downtime event earlier in the week in which the guide plates where angled too tightly and blanks got pinched on the downstream of the guide.*

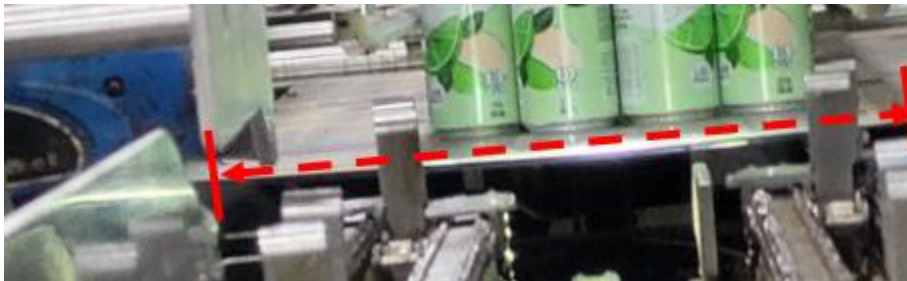
Maintenance noticed that the width setting on the blank feed area of the machine had been set to 96 using the adjustment wheel. It was previously at 105. We increased the setting back to 105 to give the case more play when transferring out of the machine.

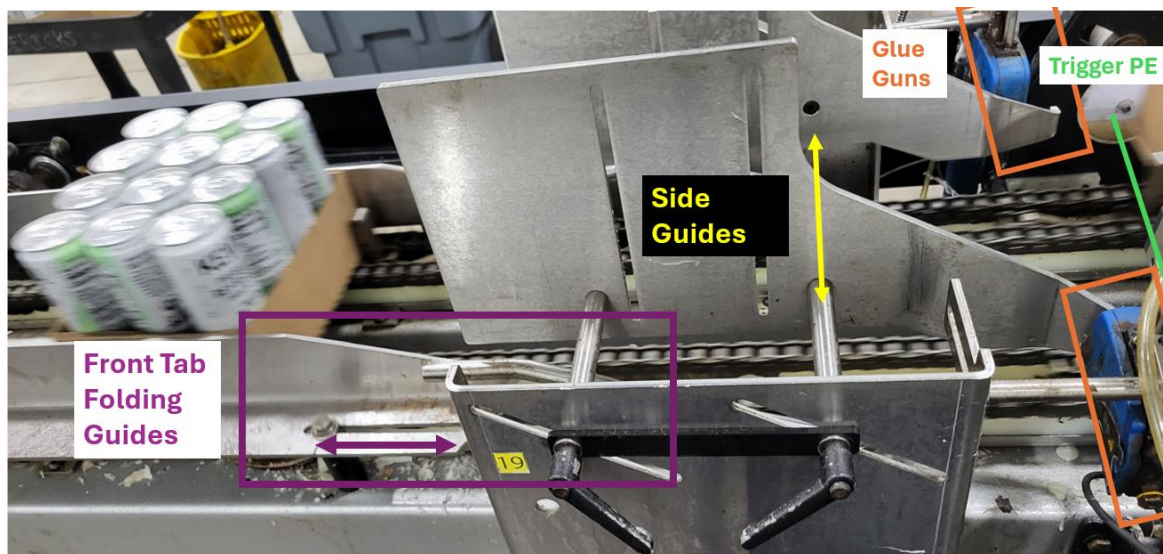
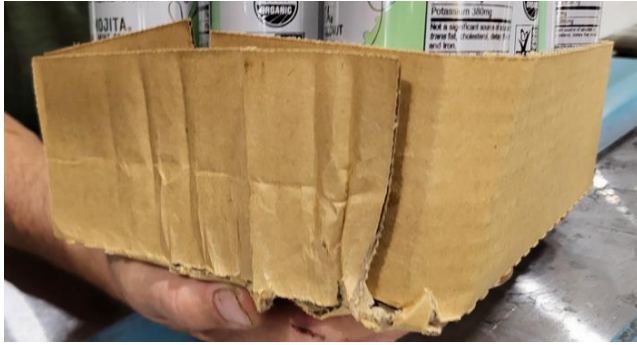
We then had a lot of issues folding the case flaps and front tabs and glueing them shut. Arpac and maintenance started by adjusting the side guides and the front tab folding guide.

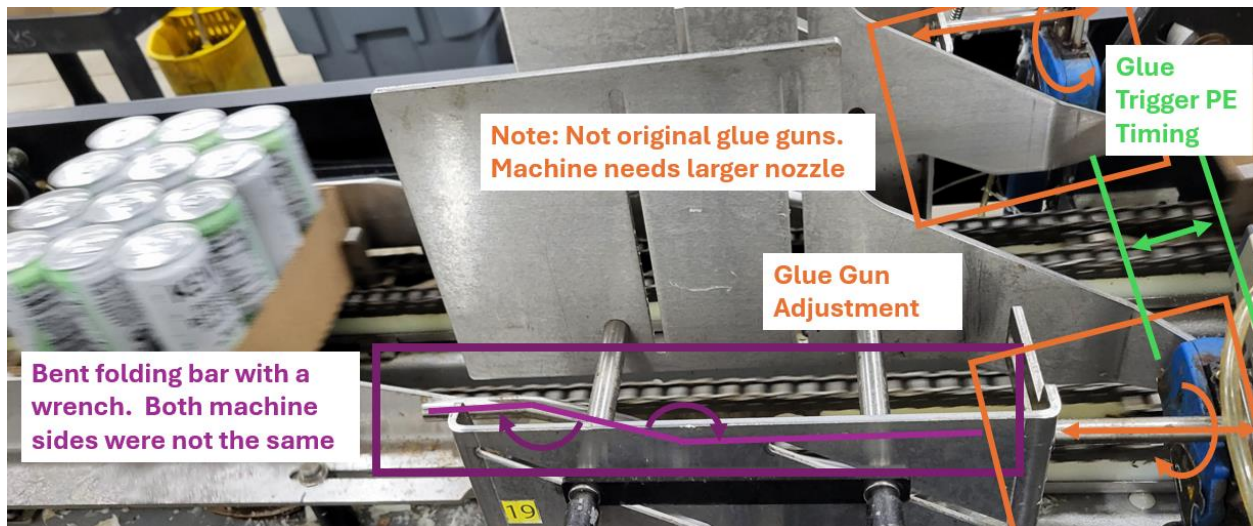
The trays had issues staying glued closed and deforming on the guides. Maintenance increased the pressure on the glue unit and modified the temperature to try to get a wider spray. I'm told that this pressure and temperature get adjusted regularly. Maintenance recommended different glue guns with a wider nozzle. The glue guns on the machine currently are not the ones that came with the machine but rather ones that were taken from somewhere else. We don't know the size of the nozzle since the label has been rubbed off.

The mounting bolts on the glue guns were also loose, and the glue guns were moved. Maintenance re-adjusted them and then set the settings on the HMI again to control the timing between the PE and the glue pulses per the new glue gun position. We had a lot of trouble getting the trays to glue shut and found that the two flap folder guides on each side of the machine were bent differently. Maintenance bent the side that we were having trouble with using a wrench.

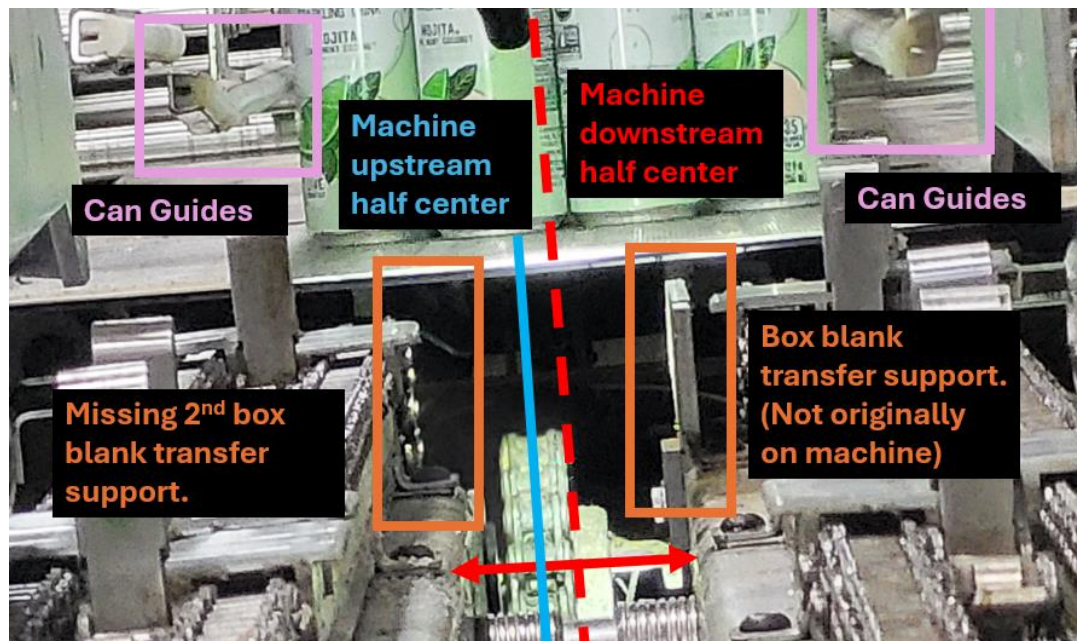
The blanks were not coming out of the machine in the center location. Note that the blank/can feed upstream half of the machine is not centered with the downstream lug chain half of the machine.

Re-centering the machine will be a significant task, and it is not feasible to do for this troubleshooting. To account for this, the can guides are adjusted to discharge cans to compensate for this. We had issues with the cases not being centered on the chain lugs as they moved to the flap/tab folding and glue areas creating many folding and gluing issues. Arpac adjusted the centering of the blank guide in the machine to better center the blank.
