## **Arpac Tray Packer Troubleshooting Report**

Troubleshooting occurred on Sept 19, 2014

Written by Ben Neher – Westrock Automation Integration Engineer – 9/22/24

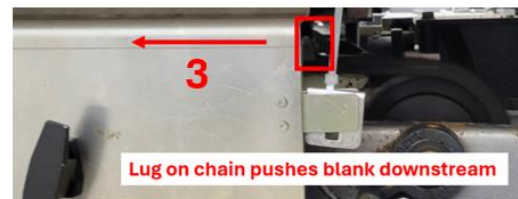
1. Blank moved into machine with an enclosed feed roller perpendicular to machine
2. Blank hits the metal backstop
3. Blank is pushed downstream by a lug on a chain. **Jam Location \***

Area is completely enclosed by:

- A. Safety Door with safety switch
- B. Blank metal backstop needed to stop the blank
- C. Top diamond plate the cans slide across.

Note that there is a fabricated guide inside the machine (not included with the original machine) on the transition of blanks from the perpendicular entry point to the downstream. Take note of this as it will be discussed later in this report.

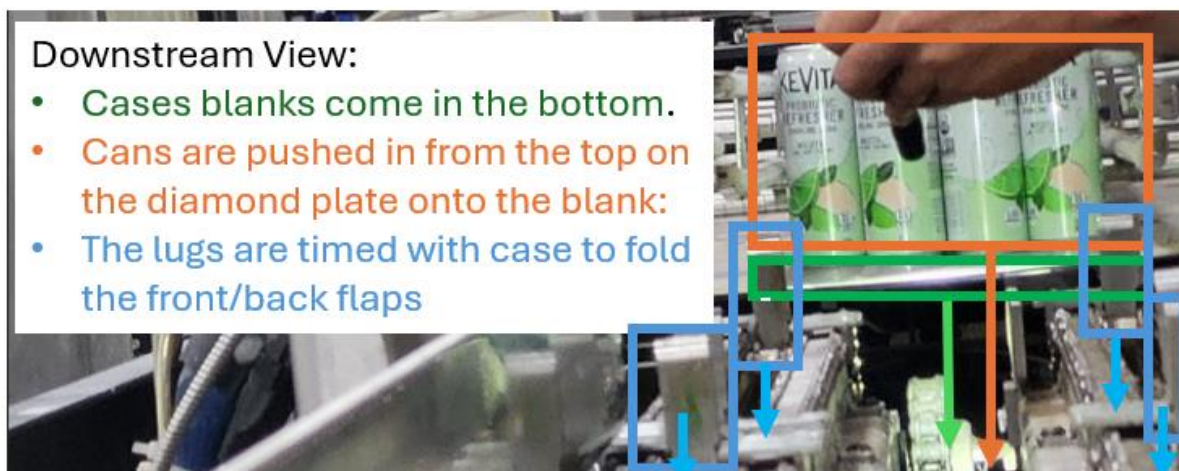
2. As both the cans and blanks are transferred downstream, the cans go onto the blanks and both go onto the lug chain.

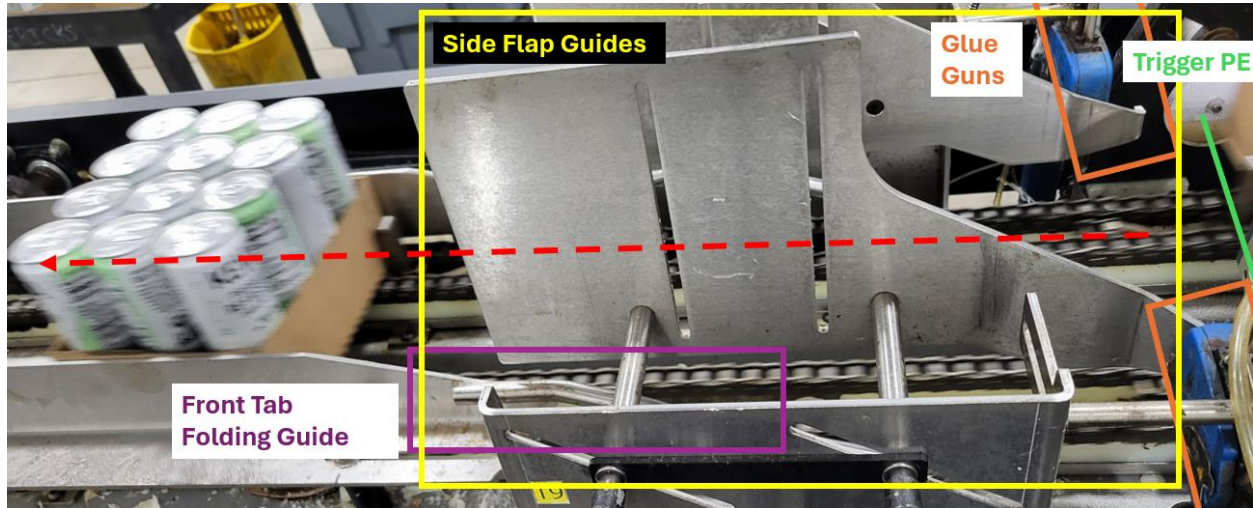
3. The flaps/tabs are folded and glued by going through mechanical guides and glue guns that fire based on a trigger PE (note: rear flap folder not shown below, but this was not an issue).
